**NSWCCD-63-TR-2001/104** March 2001

## **Identification of Weldeck Washout Discharge Constituents: Summary Report**

Survivability, Structures, and Materials Directorate  
Technical Report

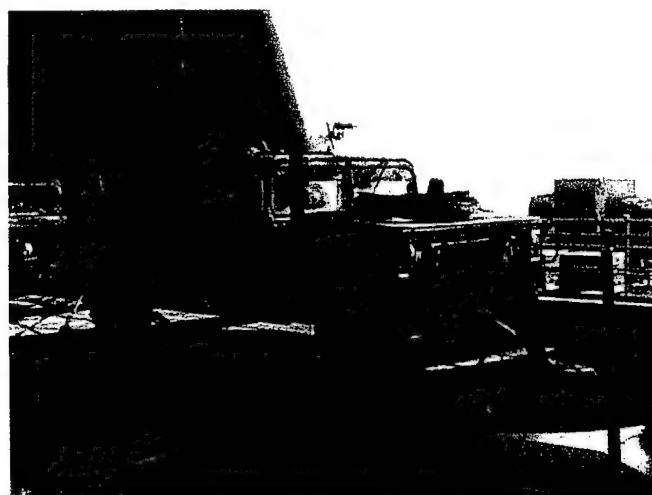
High Mobility Multipurpose Wheeled Vehicle (HMMWV)

***High Mobility Multipurpose Wheeled Vehicles***<sup>3</sup>. High Mobility Multipurpose Wheeled Vehicles (HMMWVs), provide a variety of wheeled vehicle platforms. They can function as a cargo and troop carrier, armament carrier, missile system carrier, shelter carrier, and as a ambulance. The vehicles are 15 feet long, 7 feet wide, and are typically manned by a crew of four, depending on HMMWV configuration.
